ISUZU D-Max Crew Cab
Standard Safety Equipment

2022

Tested Model	Isuzu D-MAX Crew Cab 1.9 diesel, RHD
Body Type	- 4 door double cab
Year Of Publication	2022
Kerb Weight	2030kg
VIN From Which Rating Applies	- all D-MAX Crew Cabs
Class	Pick-up

The Isuzu D-MAX Crew Cab was rated by Euro NCAP in 2020. Since then, Isuzu have improved the performance of the knee airbag and this 2022 rating combines new frontal impact tests with the results of tests done in 2020.

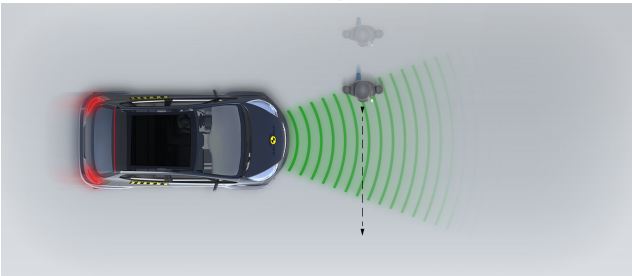
Adult crossing the road

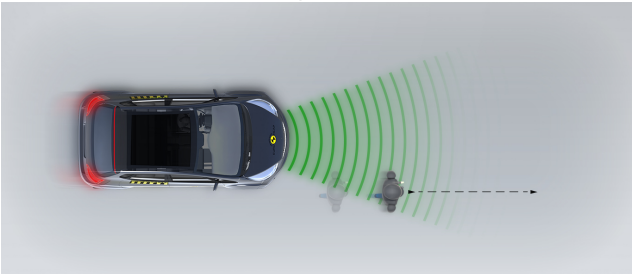
Adult along the roadside

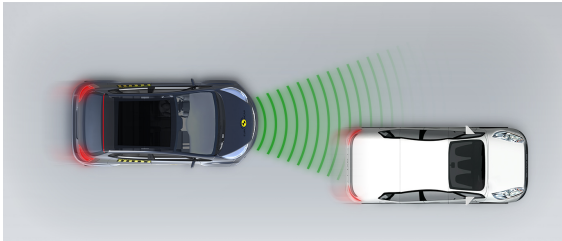
Approaching a slower moving car
